TEST REPORT

Shear Wall Test On Sing Walls

SINGHOME COMPANY

October 4th, 2002

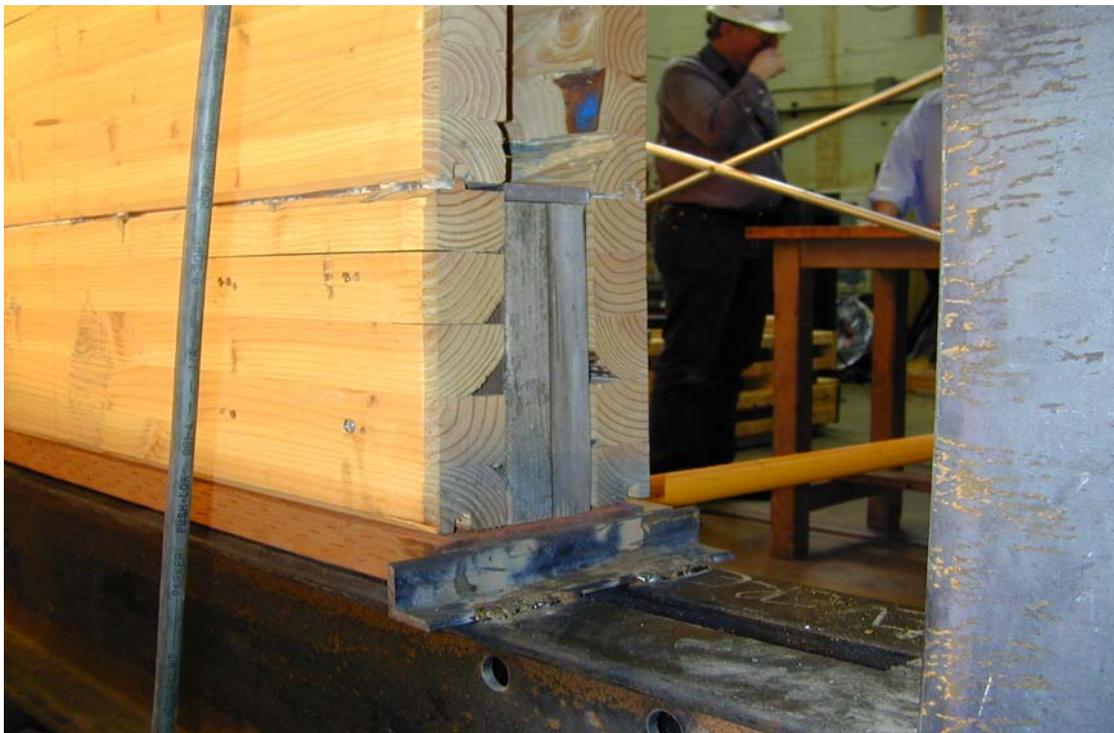
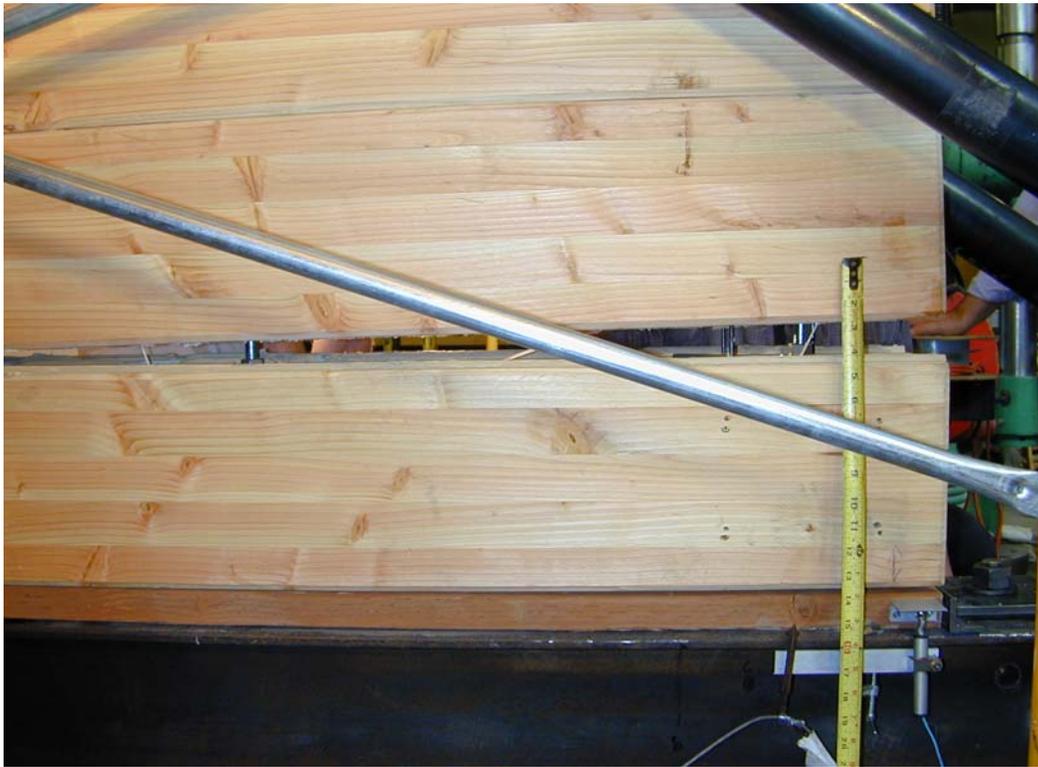
Plate 3

TEST RESULTS: (Appendix A) Graph I shows an array of computer plots for a number of displacement cycles. Graph II shows an arbitrarily selected plot of the “FIVE TENTHS” displacement cycle. Most important is the “1.3 - INCH” cycle since, in this, structural failure occurred. This is shown in Graph III. Note that, at a displacement of +1.292”, the ultimate lateral load was +7.292kips. At this point an open crack appeared at the south end of the T&G interface of the base log. For the first half of the following “1.4 - INCH” cycle, at a -1.394” displacement, with a pull of -5.969 kips, a similar interface separation occurred at the north corner. For the second half of this cycle the compressive load dropped from +7.292kips to +6.65kips (see Graph IV). Failure was tensile, both in the adhesive and the Oly- Screws. A photo of the failed section on the south end is shown in Plate III. Plate IV shows failure conditions on the north corner. Two of the Oly-Screws on the north end fractured. One fractured on the south end. The remaining end Oly Screws failed either in pull-out or pull-through.

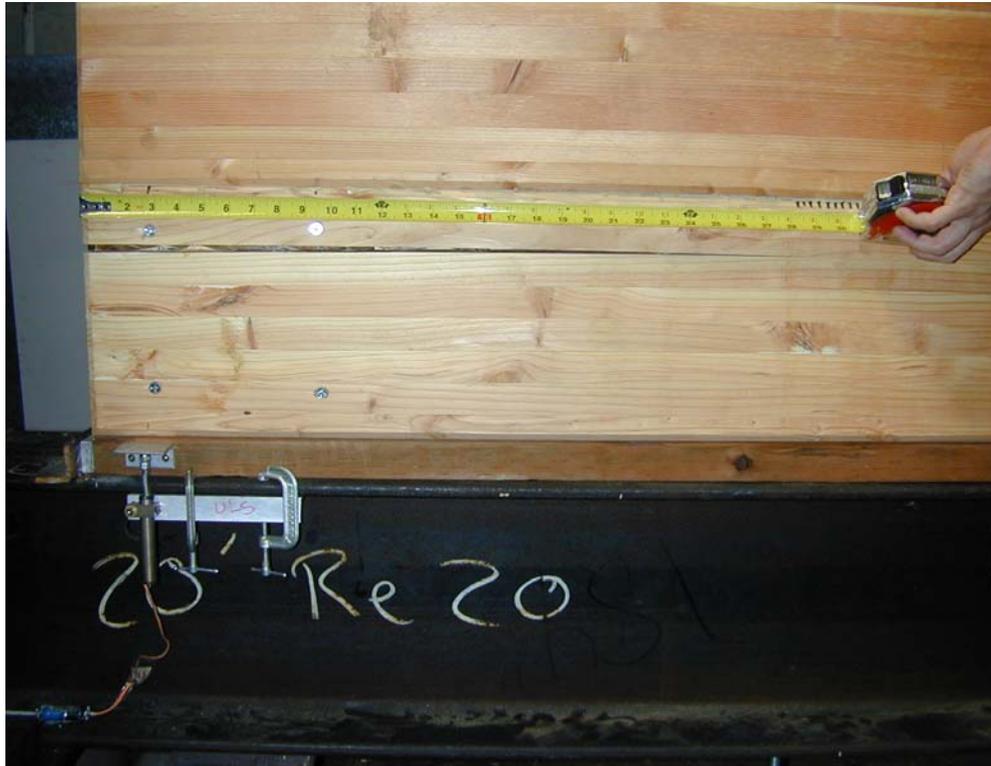
Plate 5

TEST RESULTS: Graph V is an array of a number of the smaller displacement cycles, provided only for casual observance. The most important cycles follow individually in Graphs VI through IX. Graph VI shows the “EIGHT-TENTHS cycle where, during the second half of the cycle, an ultimate compressive load of +10.586 kips produced failure. A longitudinal crack, ¼” wide and 27” long opened up in the

south end of the east plank of the base log. The crack was just below the gimlet points of the Oly-screws (three inches down from the T&G interface). Upon investigating the corresponding west plank, a similar split was observed. The compressive load rapidly dropped to +6kips Plate V shows a photo of the splitting.

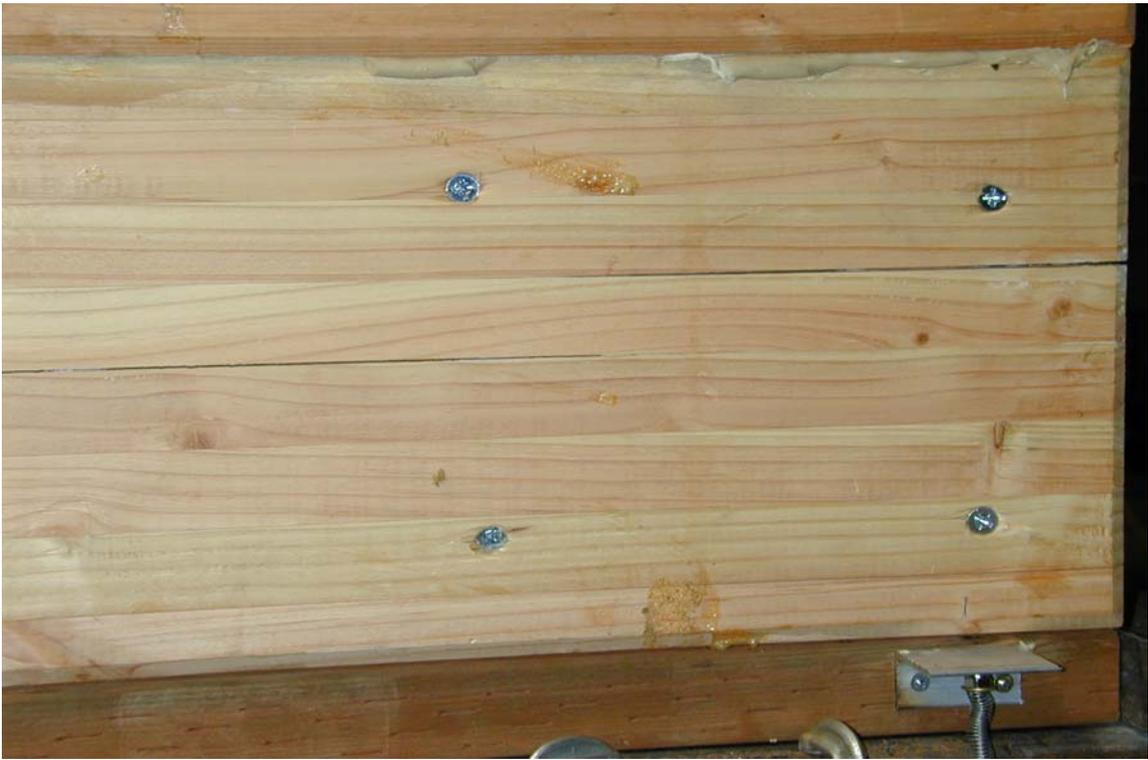
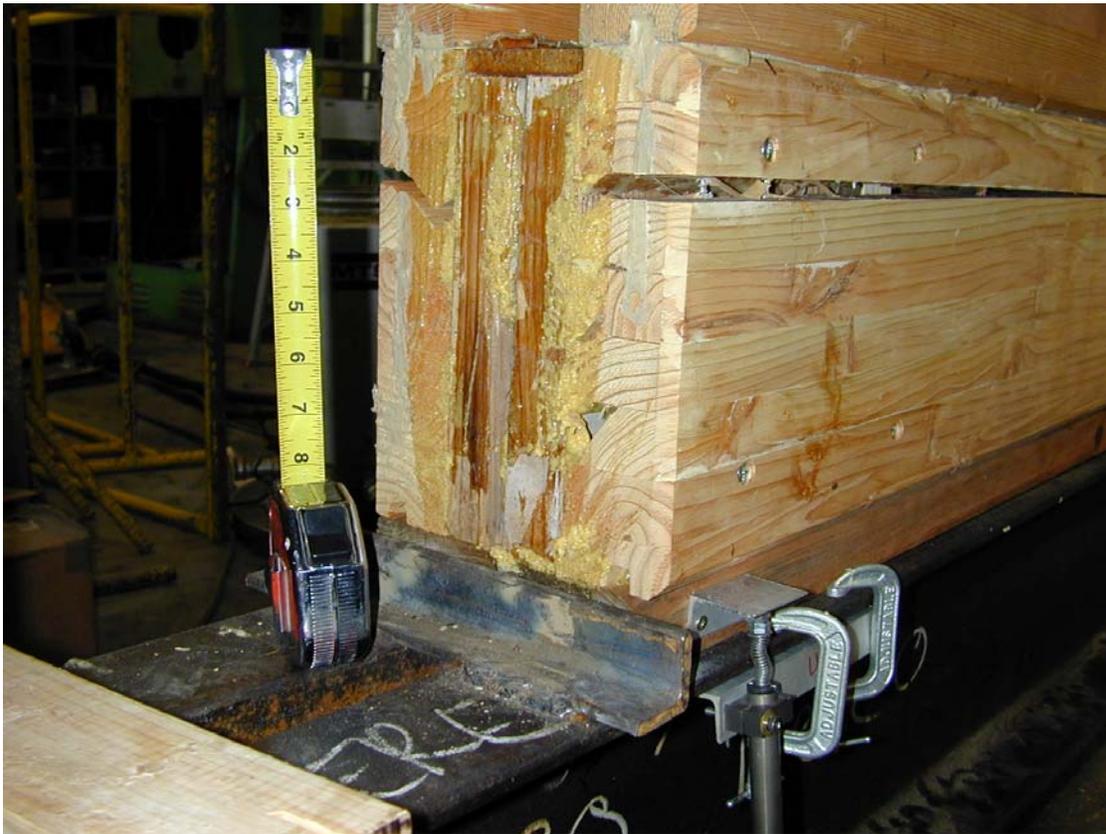
Plate 6

The modifications to Wall III served to bolster the performance of the base log T&G interface. It remained in tack throughout the test. Also, the strength of the wall improved over that of Wall 1 by about 3.3 kips. What the modifications did was to “fix the weakest link”, only to move the weakness to another (but not far away) level. There was a combined failure. First, the upper three inches of the 2 ” by 12 ” spacer glued surfaces failed in shear. This left only the two base planks to take the tension. The wood failed in tension perpendicular to the grain. The same kind of failure occurred at both ends. Close-ups of the Wall III failures are shown in Plates VI and VII

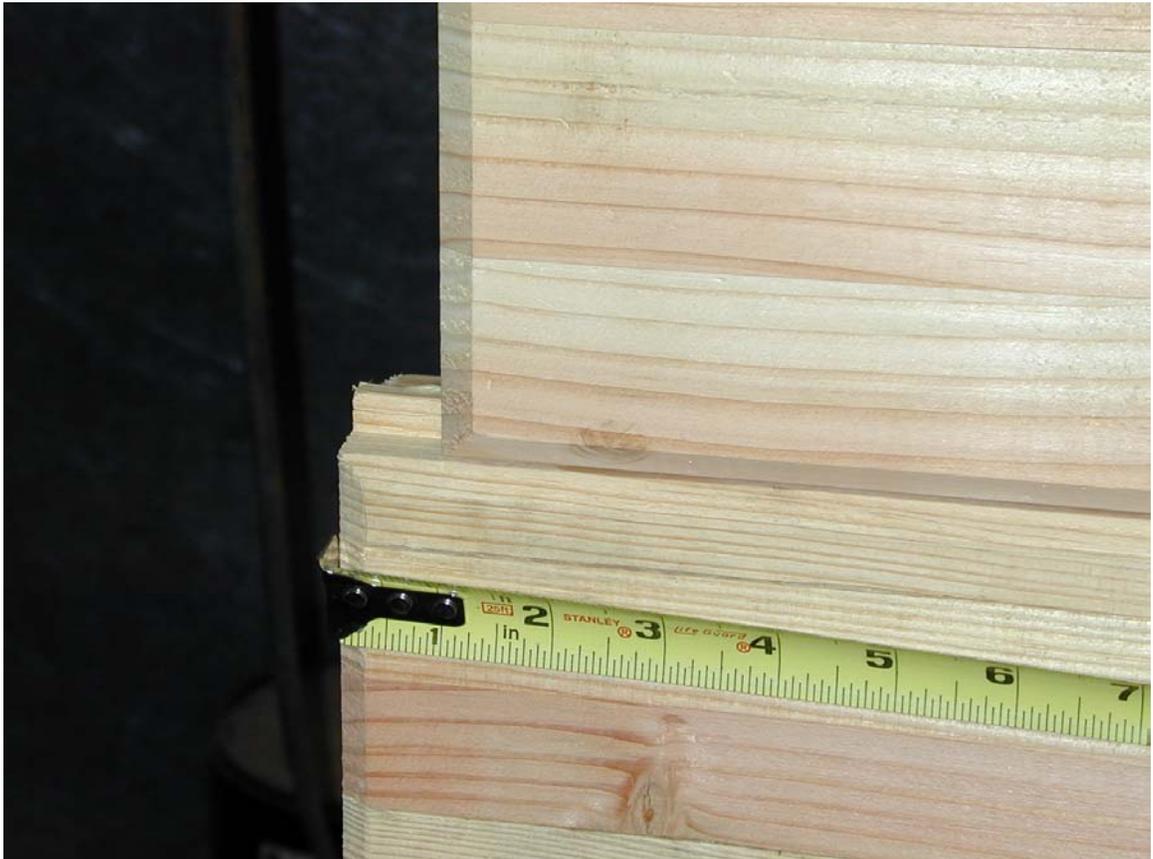
Plate 9

TEST RESULTS: From the outset, this wall exhibited some strange behavior. Upon loading, there was the sound from sliding wood surfaces, which amplified with each successive cycle. Successive cycles in the lower increment range produced small visible relative horizontal displacements along the T&G interfaces. The wall was behaving somewhat like a deck of well-used cards. Upon reaching the end of the “NINE-TENTHS” cycle, the wall produced the sound of a loud crack. The third interface from the base of the rack developed an instantaneous longitudinal relative displacement of about ½” (see Plate IX, showing the shift to the north). The maximum compressive load at the end of this cycle was +6.730kips. This is shown in Graph X). Graph XI of the “ONE-INCH” cycle shows the “dropping off” of the “ultimate” loads that were experienced through each half of the “NINE-TENTHS” cycle. Shear failure was obviously in the adhesive along the interface.

An investigation into this strange behavior revealed the fact that this wall, which was fabricated at the Sing Mill, contained little (if any) glue along the field seams. The employee reported that he placed, at best, a thin layer of adhesive only along the tongue surfaces of each log. This shortage of bond surface, along with relatively minimal curing pressure provided by the ten Oly-Screws, proved to be a disaster. Furthermore, this wall, in the process of temporary storage and transportation, was handled in the same way as was Wall I. If the field seams developed any bond strength at all, it could have been destroyed, in part, through handling.

When this test was completed, the process of returning the actuator to its zero position was such as to return this “stack of cards” to its original orderly vertical pile. Aside from some local wood crushing next to the Oly-Screws, the wall was undamaged. As an aftermath, the writer took the opportunity to interject an experiment. Using a bonding agent named “MOR-AD-M513”, a quick drying, insoluble adhesive, the T&G field seams were caulked and allowed to cure for three days. The procedure could not accurately be described as “injection gluing”, but it was intended to certainly suggest a potential procedure for “field post gluing”.

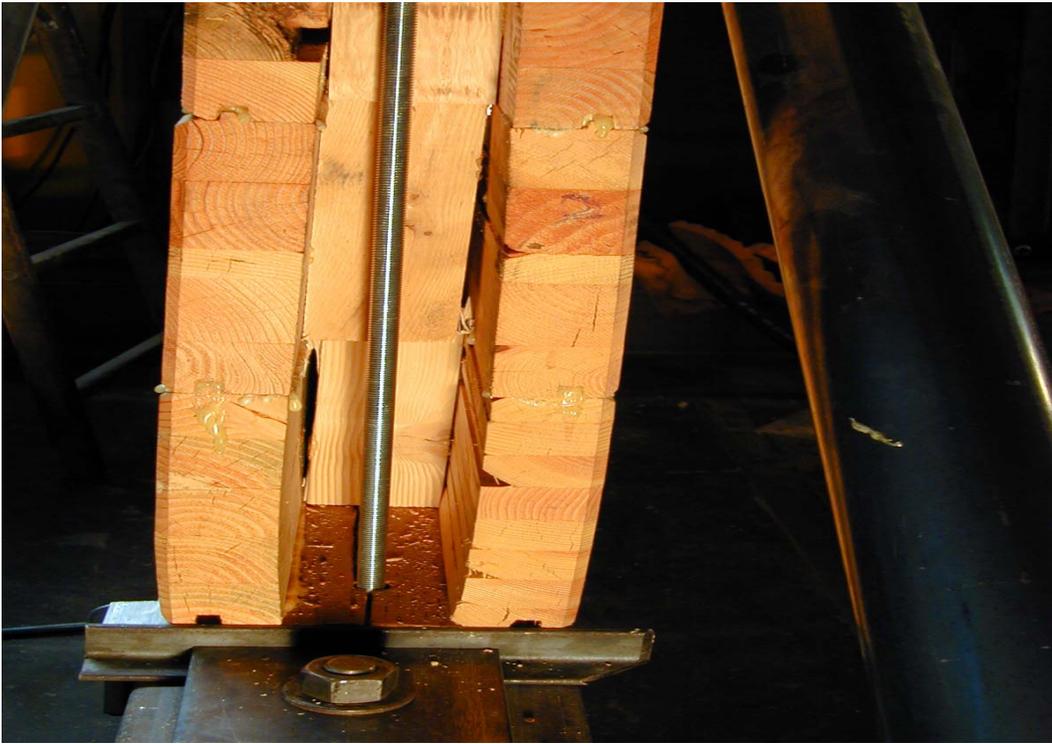
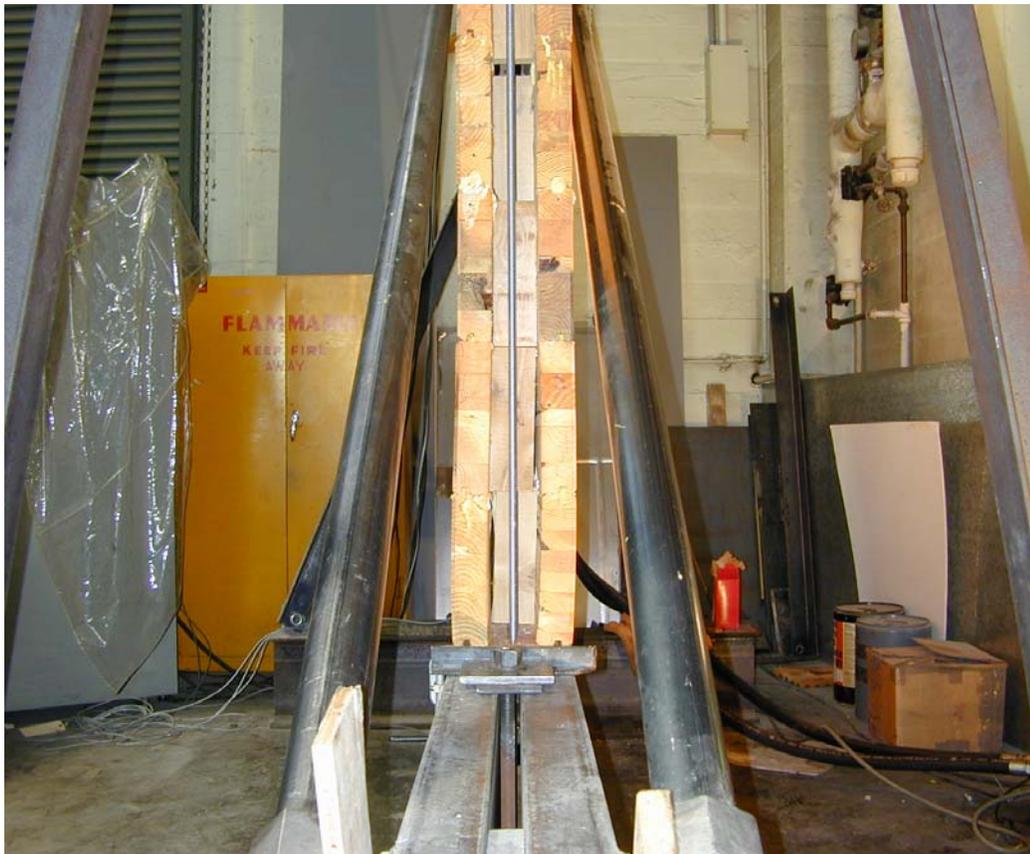
Plate 10

Observation of the wall at this point revealed similar developments at both ends of the base log. The sole 2” by 8” crushed to produce the shape of an arch along its top surface. Planks on both sides of the log began to rotate outward causing the wall to produce a local “bulge” buckle. This in turn caused a tension failure in the glue surface between a plank and a 2” by 4” spacer. This pair of failures is shown first in Plate X (south end) and next in Plate XI (north end).

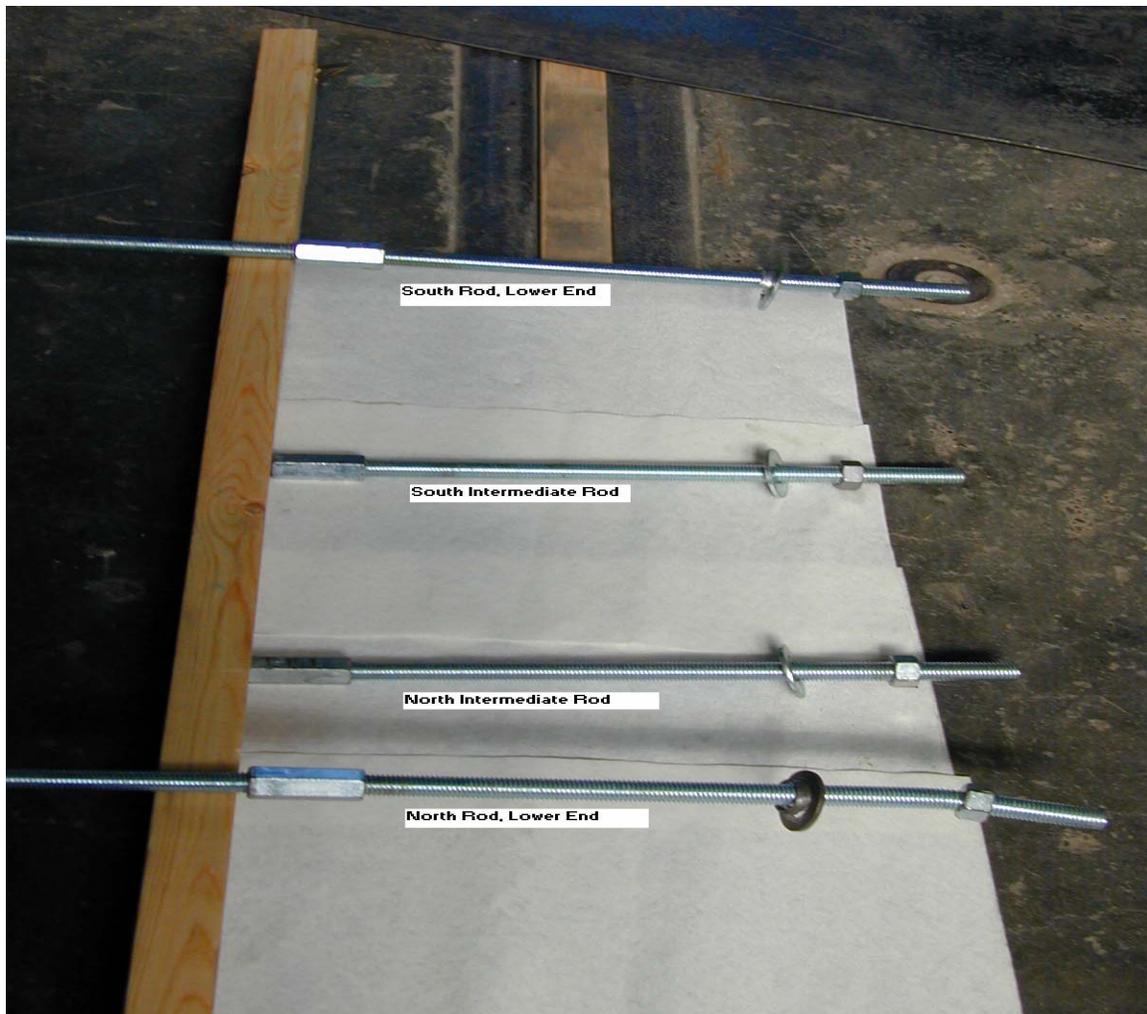
Plate 12

Of interesting note is the fact that the wall, under the subsequent displacement cycle (“1.6 INCH) exhibited renewed load bearing capability (see Graph XV). The cycling continued. During the first half of the 1.7 INCH cycle (see Graph XVI), at a load of -10.636 kips, there was a snapping of steel. The nut on the north tie-rod, under the rack channel, sheared through the washer.

Some repairs were made on the tie-downs. Replacement nuts, along with doubled-up washers, were fitted to all four, and a final cycle was begun. During the first half of the “1.8 INCH “ cycle (see Graph XVII), at a displacement of -1.756 ” and an absolute ultimate load of -20.134 kips, collectively catastrophic failure was reached. Local buckle was observed in the first two logs in the lower corners. This was accompanied by a stripping of the thread at the top of the south tie - down rod. Throughout all of this, the properly placed adhesive along the field seams behaved extremely well. There was no evidence of failure it that glue, either in shear or in tension. Plate XII is an exhibit of the damaged tie-downs.
