TEST REPORT

Shear Wall Test On Sing Walls

SINGHOME COMPANY

October 4th, 2002

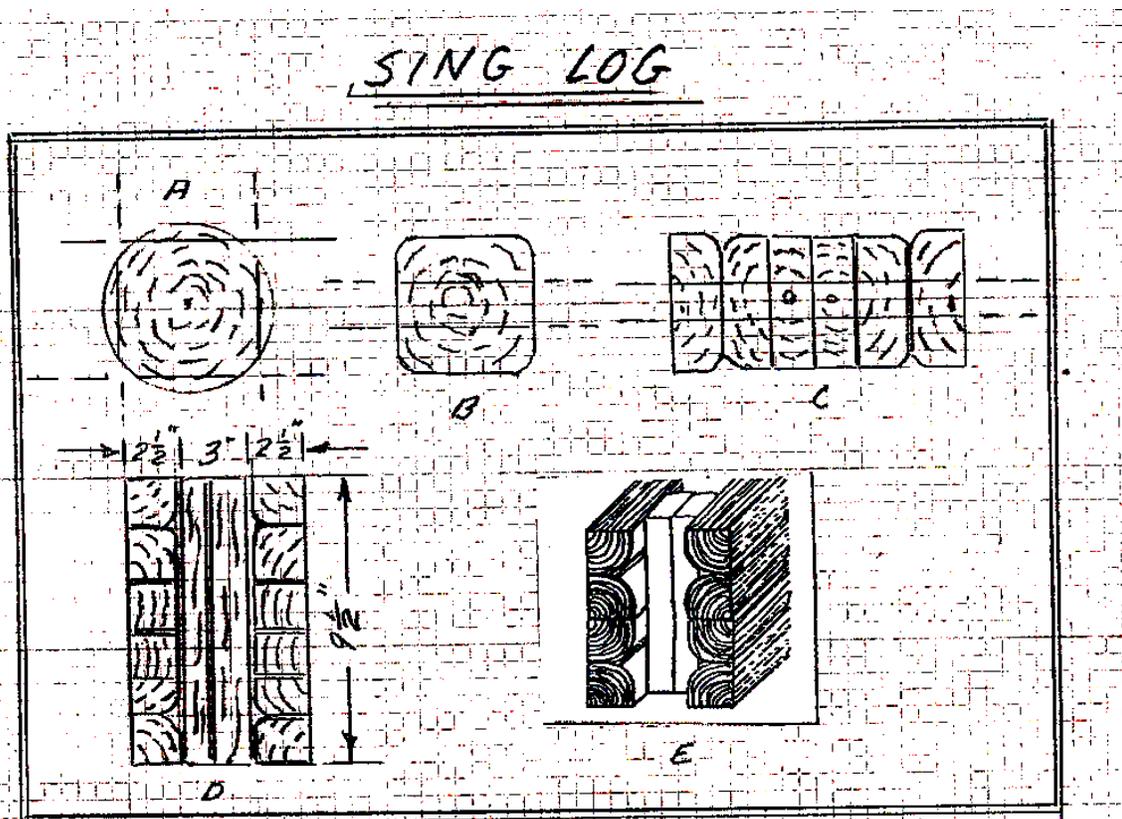
FIG. I

Sing logs begin with the sawing of small logs (see Fig. I-A).

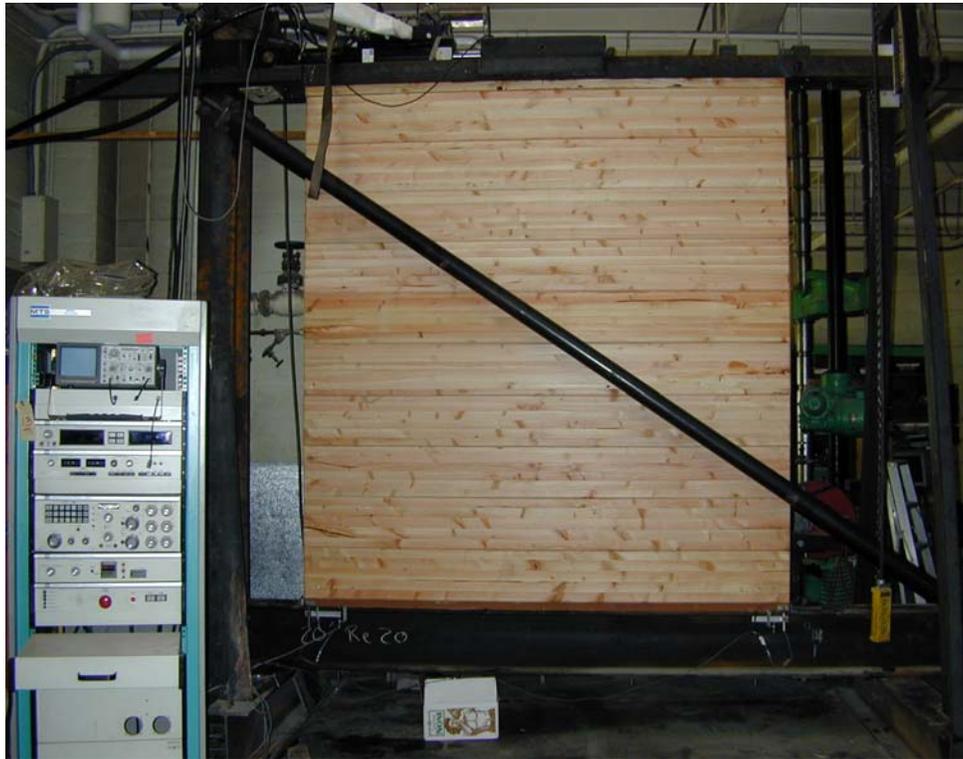
Plate 1

A photograph of the loading rack, with one of the walls in place, is shown in Plate I.

Plate I shows Shear Wall I in place. Figure II shows its dimensions. Also, it indicates the important features. The wall is characterized by tie rods that extend only through the base log. Four 5/8" diameter "All-thread" anchor rods complete the tie-down. Four couplings directly below the sole plate were snuggled up, mainly for the purpose of holding things together during wall fabrication and transport. Once the wall was seated on the base of the rack,

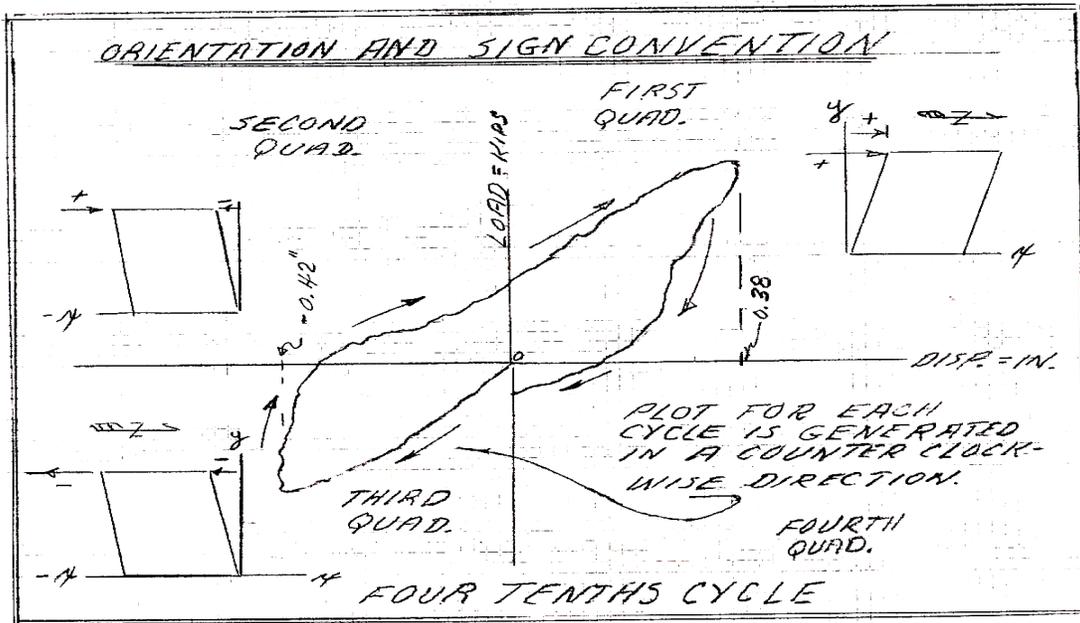
FIG. III

Maximum displacements for each cycle were chosen to increase by successive increments of 0.10". Thus the test continued on up to the condition associated with ultimate load. A sample plot is shown in Fig. III. This figure essentially summarizes the orientation and sign convention. Note that the figure arbitrarily illustrates the so-called "FOUR-TENTHS" cycle. The plot is randomly sketched in, purely for illustration. In the computer graphs to be presently reported, the limiting displacements will generally be within plus or minus 0.02" of the ideal maximum displacements desired. Accurate limiting loads will also accompany the more accurate limiting displacements. Less accurate limiting loads and displacements were recorded on a running, hand-held log sheet for each cycle in each test. These sheets are included in the appendix of this report. The numbers therein were hastily abstracted from rapidly changing screen readouts and can only be considered to be approximate.

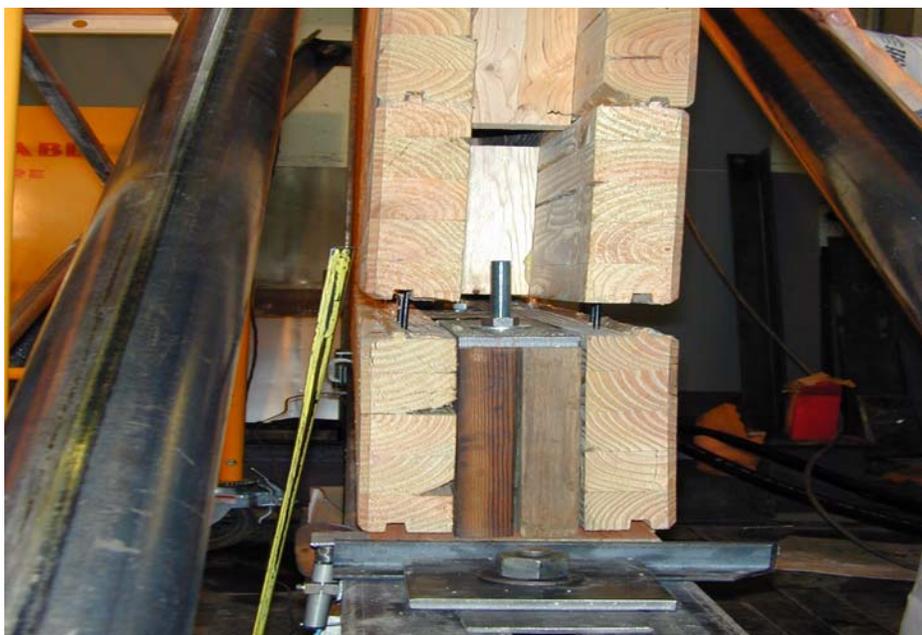
Plate 2

extension lengths of rods were required to complete the tie to steel channels on the rack. This detail is shown in Fig. IV. Also shown in this figure is a detail of the construction at the ends of the base log. Two, Douglas fir glued-in spacers, at 1 1/2" by 11" by 9 1/2", provided bearing parallel-to-grain for a 1/2" by 3" by 11" steel plate. The All-thread was then topped off with nut and washer. Four wood screws were additionally driven horizontally on each side of the base log. A photo of this connection is shown in Plate II.

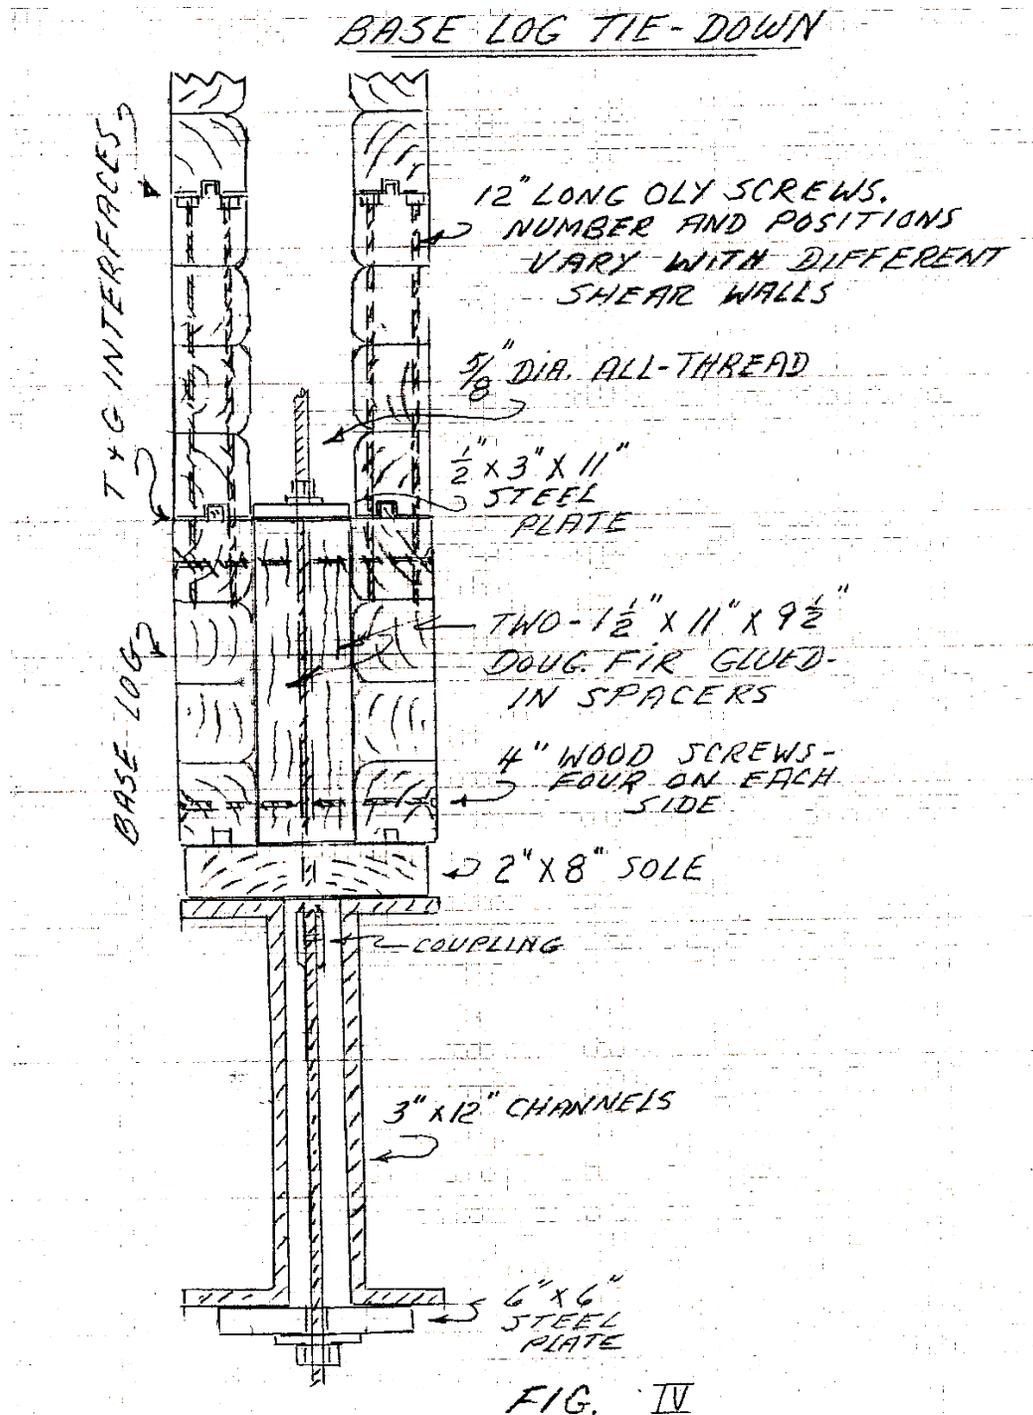
Glue adhesive and Olympic "Oly-Log" log home fasteners (or equivalent) must necessarily take the place of the tie-rods in providing for tensile loading in the logs above the tie rod ends. They are also shown in Fig. IV. "Oly-Logs are also commonly referred to as "OlyScrews"

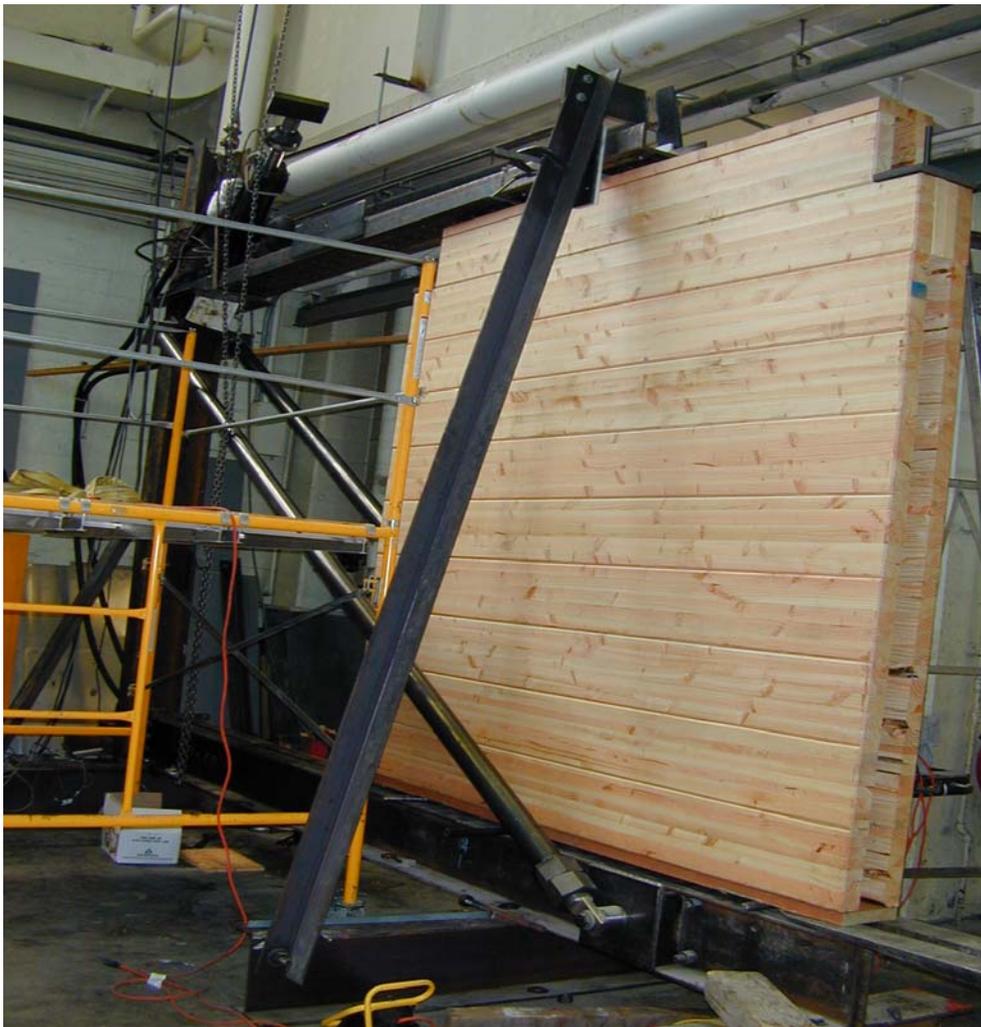
Plate 8

Shear Wall No. II was quite different from walls I and III. While it was the same size and the same species, it was characterized by end tie-down rods that extended vertically from the bottom of the rack channels to the top of the wall. Figure II shows true dimensions and exacting details of this wall. Because room was needed between the top channel on the rack and the top of the wall, for the capping of the rods with nuts, the top log was necessarily shortened 6" on each end. This wall obviously did not require the base log end bearing surfaces required in Walls I and III. The spacers in the base log were the typical doubled up 2 by 4's placed 6" in from both ends, plus others of the same placed longitudinally about every 2'. With the exception of the top two logs, all of the other logs in the wall were made the same. The second log down from the top now necessarily contained the bearing blocking. A $\frac{3}{4}$ " by 6" by 8" steel plate rested on two glued-in 1 $\frac{1}{2}$ " by 6" by 9 $\frac{1}{2}$ " blocks. The wood was subjected to compression, part in parallel and part in perpendicular to the grain. Intermediate tie-down rods were identical to those of Walls I and III. Each T&G interface contained ten Oly-Screws spaced the same as they were in Wall I. Plate VIII shows Wall II set up in the rack and ready to go.

TEST RESULTS: From the outset, this wall exhibited some strange behavior. Upon loading, there was the sound from sliding wood surfaces, which amplified with each successive cycle. Successive cycles in the lower increment range produced small visible relative horizontal displacements along the T&G interfaces. The wall was behaving somewhat like a deck of well-used cards. Upon reaching the end of the “NINE-TENTHS” cycle, the wall produced the sound of a loud crack. The third interface from the base of the rack developed an instantaneous longitudinal relative displacement of about ½” (see Plate IX, showing the shift to the north). The maximum compressive load at the end of this cycle was +6.730kips. This is shown in Graph X). Graph XI of the “ONE-INCH” cycle shows the “dropping off” of the “ultimate” loads that were experienced through each half of the “NINE-TENTHS” cycle. Shear failure was obviously in the adhesive along the interface.

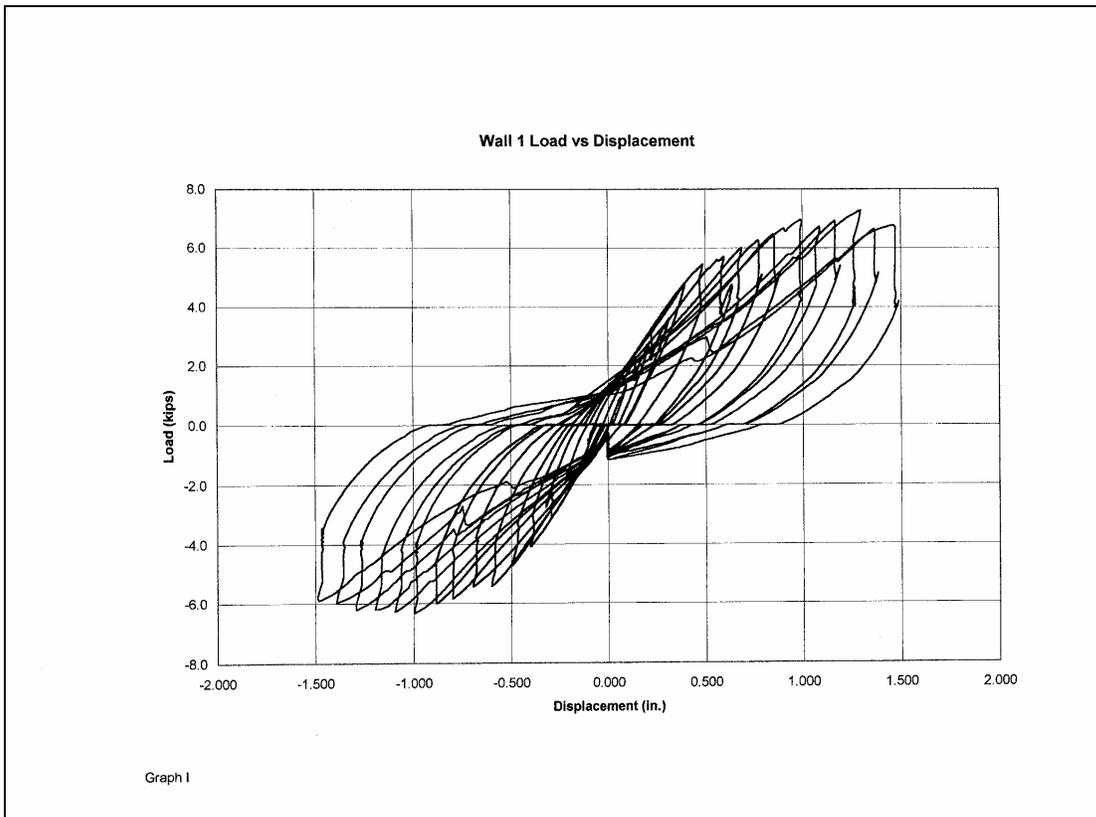
TEST RESULTS: (Appendix A) Graph I shows an array of computer plots for a number of displacement cycles. Graph II shows an arbitrarily selected plot of the “FIVE TENTHS” displacement cycle. Most important is the “1.3 - INCH” cycle since, in this, structural failure occurred. This is shown in Graph III. Note that, at a displacement of +1.292”, the ultimate lateral load was +7.292kips. At this point an open crack appeared at the south end of the T&G interface of the base log. For the first half of the following “1.4 - INCH” cycle, at a -1.394” displacement, with a pull of -5.969 kips, a similar interface separation occurred at the north corner. For the second half of this cycle the compressive load dropped from +7.292kips to +6.65kips (see Graph IV). Failure was tensile, both in the adhesive and the Oly- Screws. A photo of the failed section on the south end is shown in Plate III. Plate IV shows failure conditions on the north corner. Two of the Oly-Screws on the north end fractured. One fractured on the south end. The remaining end Oly Screws failed either in pull-out or pull-through.

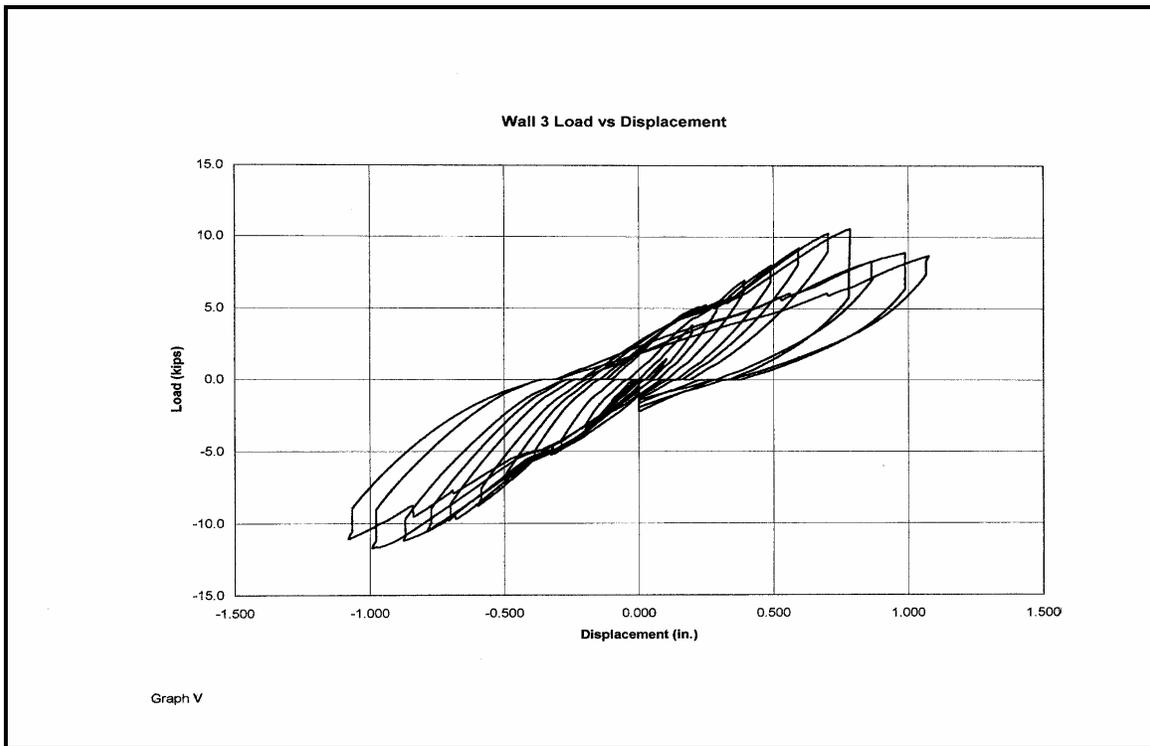
TEST RESULTS: Graph V is an array of a number of the smaller displacement cycles, provided only for casual observance. The most important cycles follow individually in Graphs VI through IX. Graph VI shows the “EIGHT-TENTHS cycle where, during the second half of the cycle, an ultimate compressive load of +10.586 kips produced failure. A longitudinal crack, ¼” wide and 27” long opened up in the

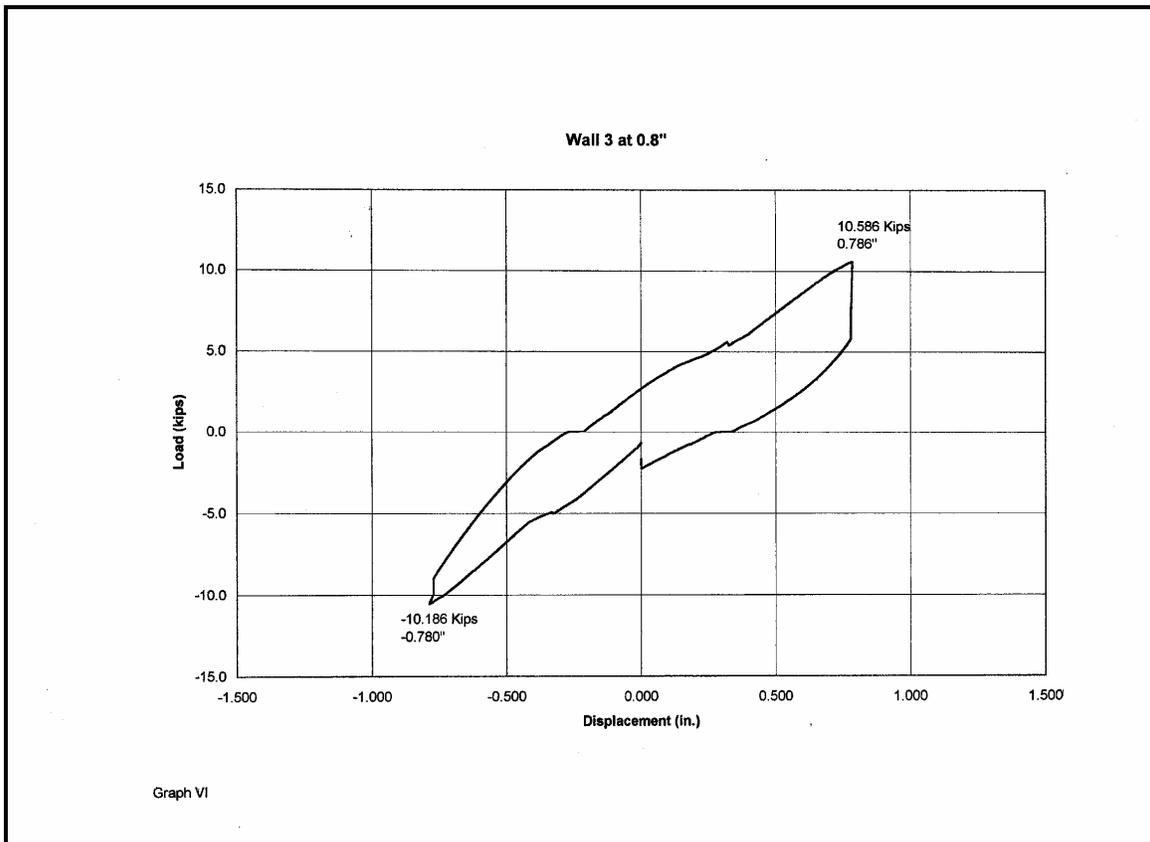
Graph VI

south end of the east plank of the base log. The crack was just below the gimlet points of the Oly-screws (three inches down from the T&G interface). Upon investigating the corresponding west plank, a similar split was observed. The compressive load rapidly dropped to +6kips Plate V shows a photo of the splitting.

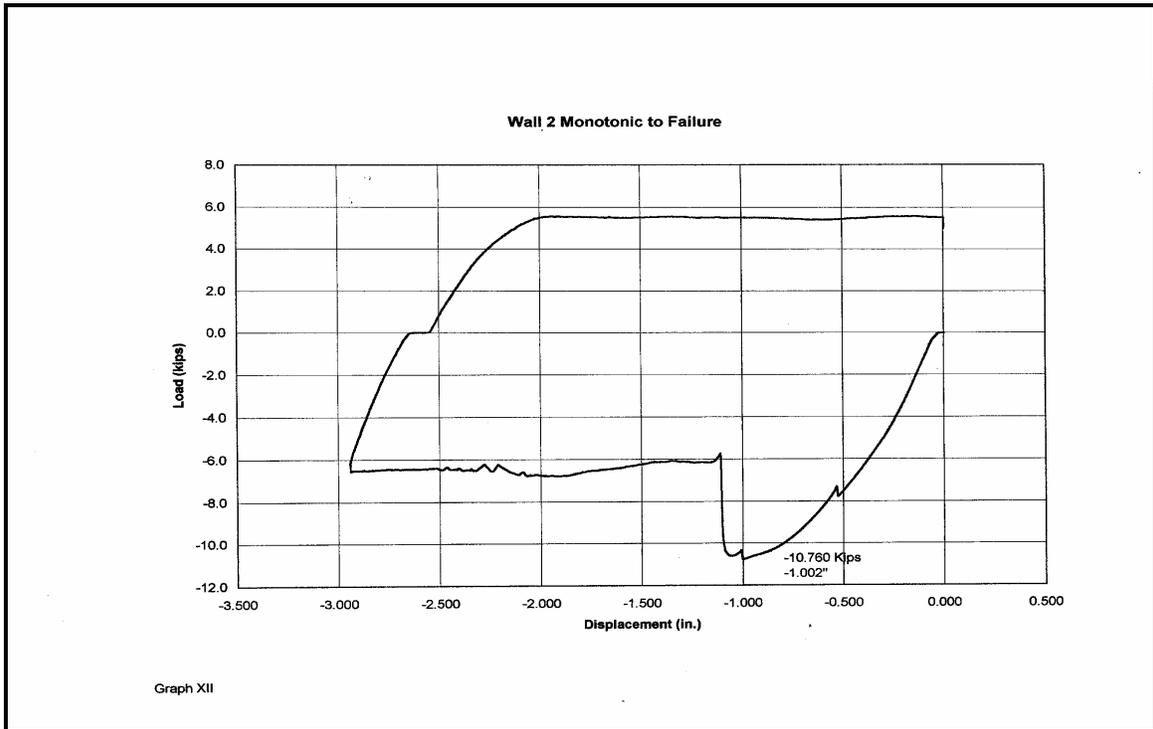
Graph XII

This modified wall was subjected to a simple monotonic (one direction) pull, the results of which are shown in Graph XII. It shows an ultimate load of minus 10.760kips an increase of about 4kips over its “no-glue” counterpart. Again the sliding type failure occurred along the third interface up from the bottom of the wall.

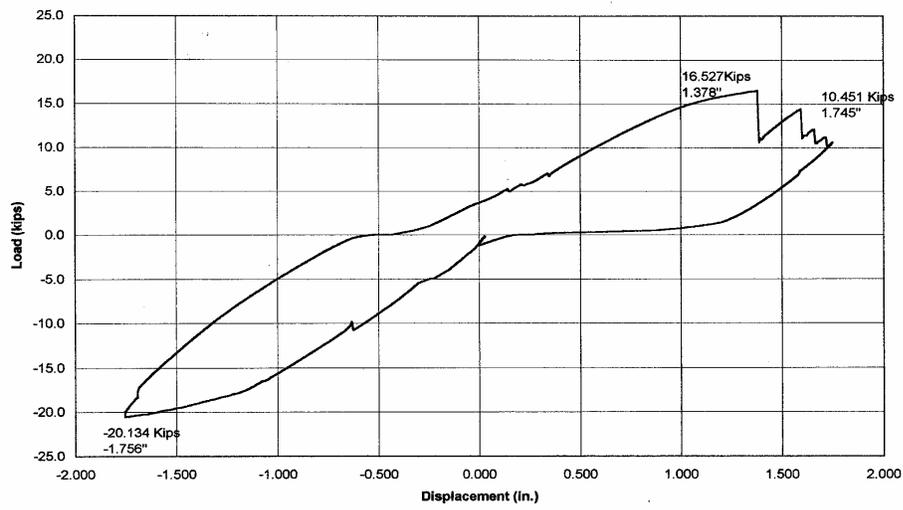
Graph XVII

Some repairs were made on the tie-downs. Replacement nuts, along with doubled-up washers, were fitted to all four, and a final cycle was begun. During the first half of the “1.8 INCH “ cycle (see Graph XVII), at a displacement of -1.756 ” and an absolute ultimate load of -20.134 kips, collectively catastrophic failure was reached. Local buckle was observed in the first two logs in the lower corners. This was accompanied by a stripping of the thread at the top of the south tie - down rod. Throughout all of this, the properly placed adhesive along the field seams behaved extremely well. There was no evidence of failure it that glue, either in shear or in tension. Plate XII is an exhibit of the damaged tie-downs.
